MAINTENANCE  
AND  
STRUCTURAL REPAIR MANUAL

FOR ADAMS BALLOONS PRODUCED UNDER TYPE CERTIFICATE  
NUMBER A1550

FIRST EDITION  
SEPTEMBER, 1981  
17 TOTAL PAGES  
REVISED JANUARY 1984  
SECOND REVISION JUNE 2015

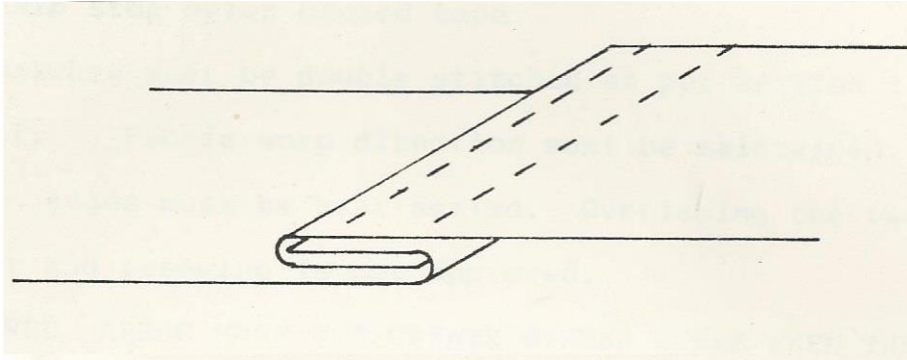
1. REPLACING COMPLETE PANELS- Use LSC2 fell seam for all panel replacements.
