MAINTENANCE  
AND  
STRUCTURAL REPAIR MANUAL

FOR ADAMS BALLOONS PRODUCED UNDER TYPE CERTIFICATE  
NUMBER A1550

FIRST EDITION  
SEPTEMBER, 1981  
17 TOTAL PAGES  
REVISED JANUARY 1984  
SECOND REVISION JUNE 2015

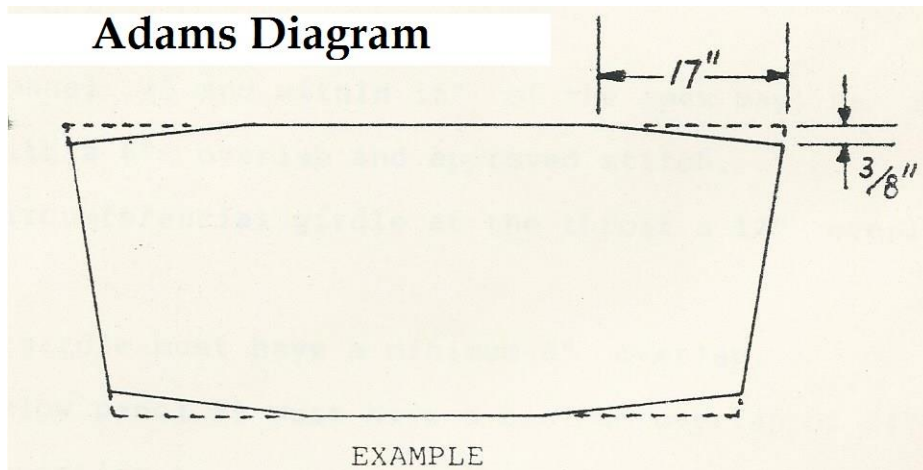
NOTE: Panels are cut with a  $\frac{3}{8}$ " taper on top and bottom. Edges extending 17" toward the center of each panel except deflation port panels and #1 NOMEX throat panels. All panels use between 42 and 60" fabric and all cuts are straight lines.
